CALEXICO HIGH SCHOOL 9TH GRADE CAMPUS

824 Blair Avenue, Calexico, CA 92231

EXISTING SITE CONDITIONS

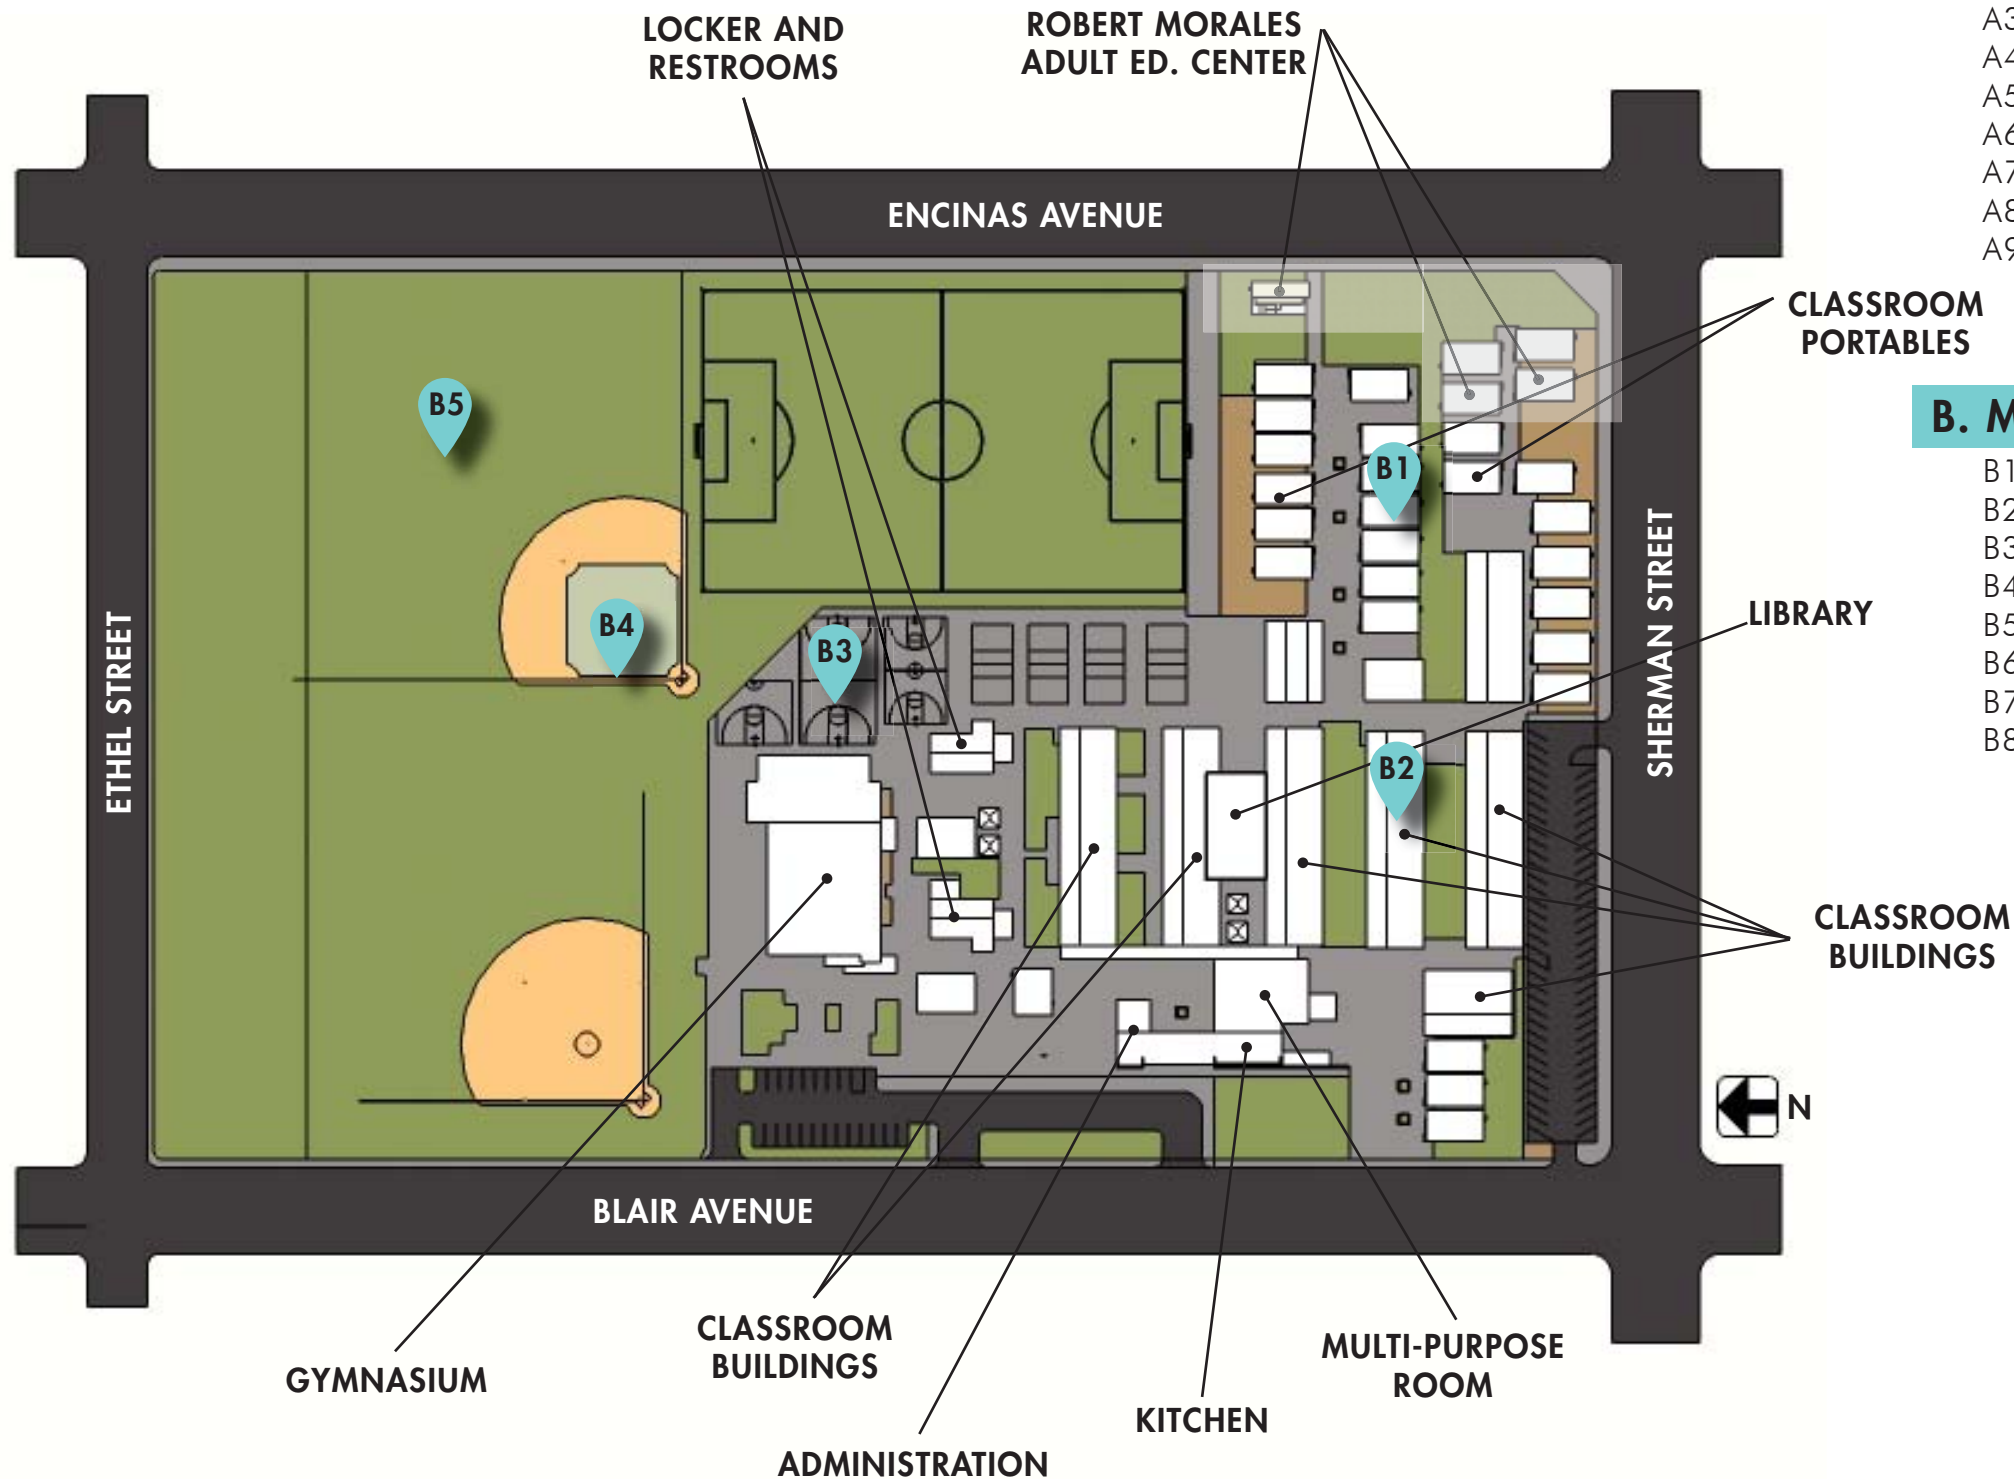
- A1 Concrete walkways are pitted and uneven
- A2 Chainlink gates need accessible hardware
- A3 Asphalt paving deteriorated
- A4 Path of travel not Title 24 compliant
- A5 Site is not title 24 compliant
- A6 Not enough shade structures and trees
- A7 Chainlink fencing damaged
- A8 Existing shade structure fabric deteriorated
- A9 Empty tree wells

- B1 Too many portables
- B2 Roofs are deteriorating
- B3 Basketball and volleyball nets deteriorated
- B4 Baseball backstops need replacing
- B5 Soil eroding in fields
- B6 Paint peeling and cracking
- B7 Signage peeling and faded and damaged
- B8 Gravel infill

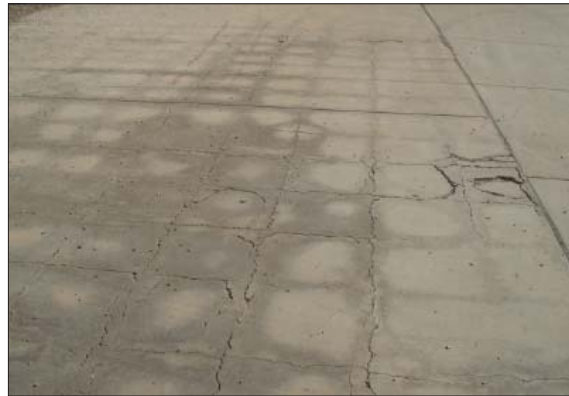
A1 Concrete walkways are pitted and uneven

Concrete walkways and courts are pitted, chipped, and cracked. Some areas have heaved or settled along the paths of travel.

Solution: Repair or replace concrete as needed.

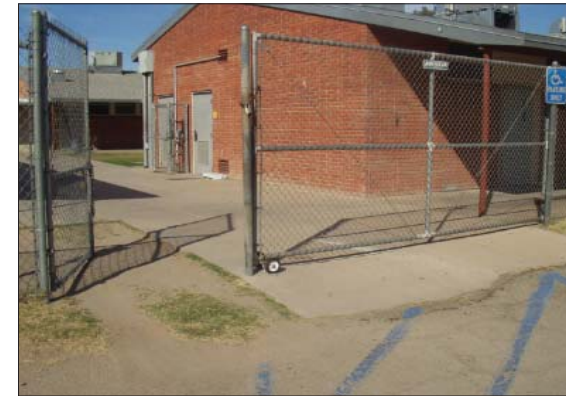
A4 Path of travel

Path of travel does not meet Title 24 requirements.

Solution: Provide Title 24 compliant concrete walks and ramps as needed.

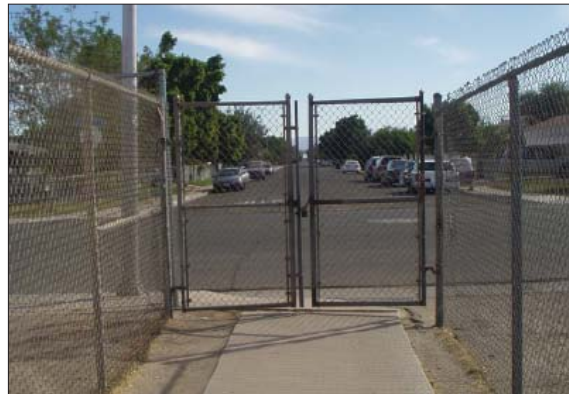
A2 Gate Hardware

Chainlink exit gates do not have accessible exit hardware

Solution: Replace gates and provide Title 24 compliant hardware.

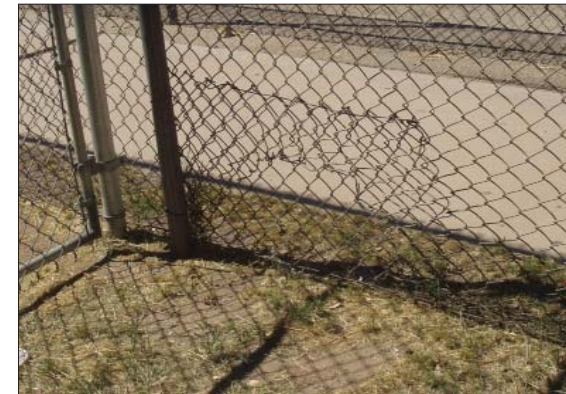
A7 Perimeter fencing

Chainlink fencing damaged in various locations.

Solution: Replace fencing as required to secure campus.

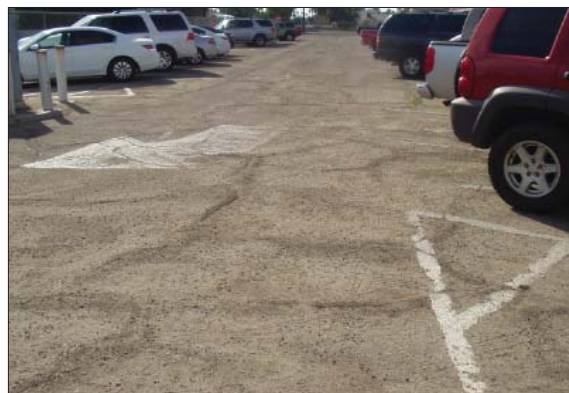
A3 Asphalt paving

Asphalt paving is deteriorating from exposure to the harsh elements causing tripping hazards and is not Title 24 compliant for smooth path of travel surface.

Solution: Replace asphalt paving and re-stripe parking spaces.

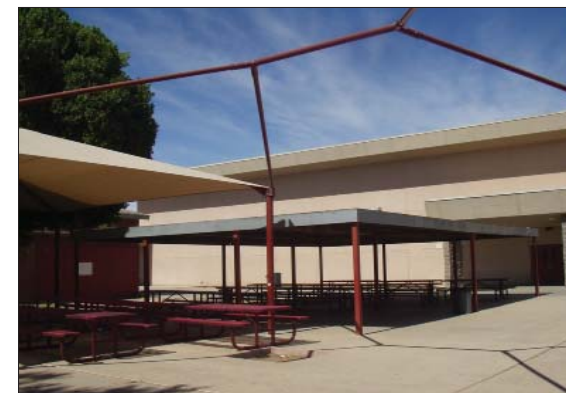
A8 Shade structure fabric

Shade structure fabric has deteriorated in the harsh elements.

Solution: Provide metal roofs for existing structures.

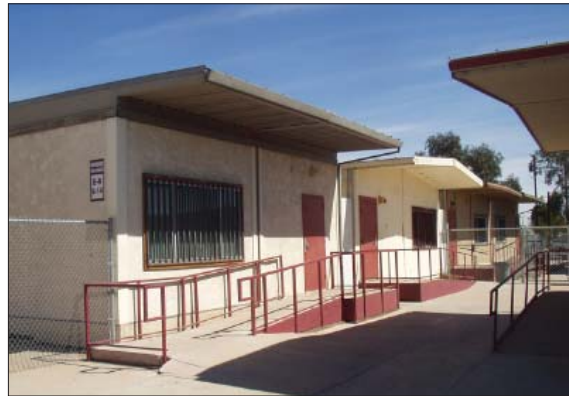
B1 Too many portables

Campus has too many portables and many are deteriorating.

Solution: Replace portables with new permanent classroom building(s).

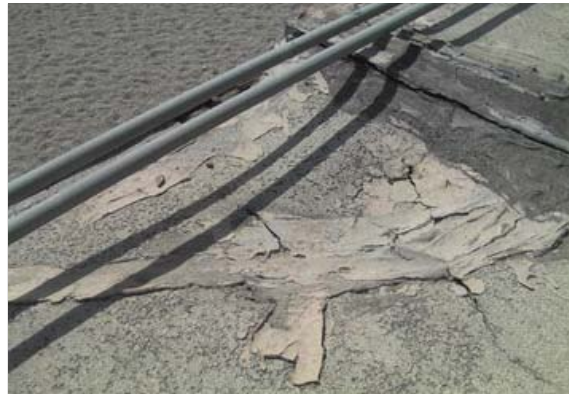
B2 Roofs are deteriorating

The roof penetration failures and roof damage is prolific. The majority of the failures on this school were found to be the result of poor details, design and drainage. Pigeon dropping are prolific on the gym roof and due to corrosive nature is weakening the roof system

Solution: Provide new roofs at permanent buildings.

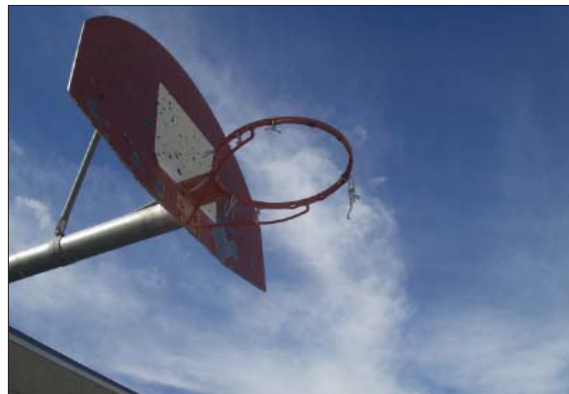
Basketball and Volleyball Nets

Basketball and volleyball nets have deteriorated in the elements.

Solution: Provide new nets

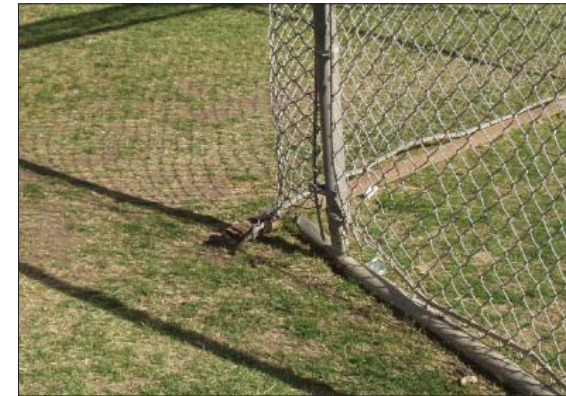
B4 Baseball Backstops

Backstops are rusted, worn and deteriorated.

Solution: Provide new backstops.

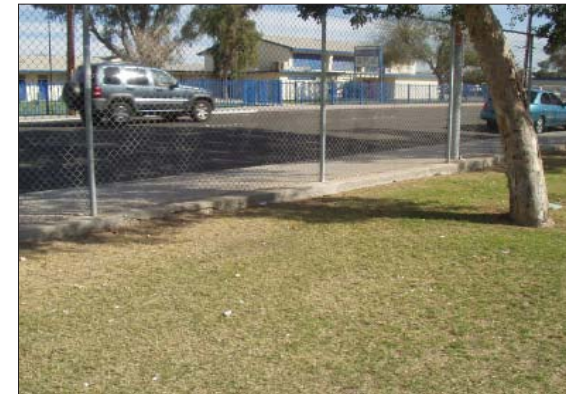
B5 Soil Erosion

Soil has eroded and left concrete footings exposed.

Solution: Import clean soil, regrade field and reseed lawns.

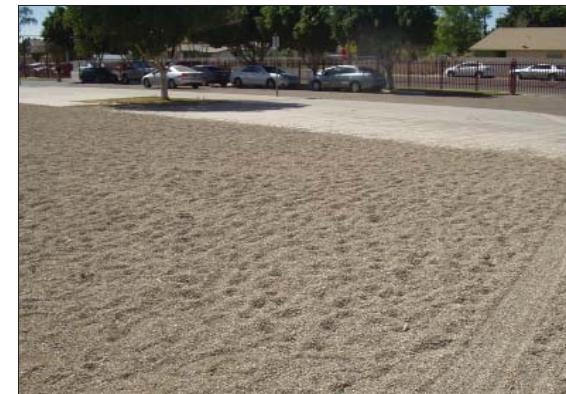
B8 Gravel Infill

Several buildings were removed and the open area was filled with gravel. Gravel is causing a mess in the surrounding surfaces.

Solution: Remove gravel and fill with concrete.

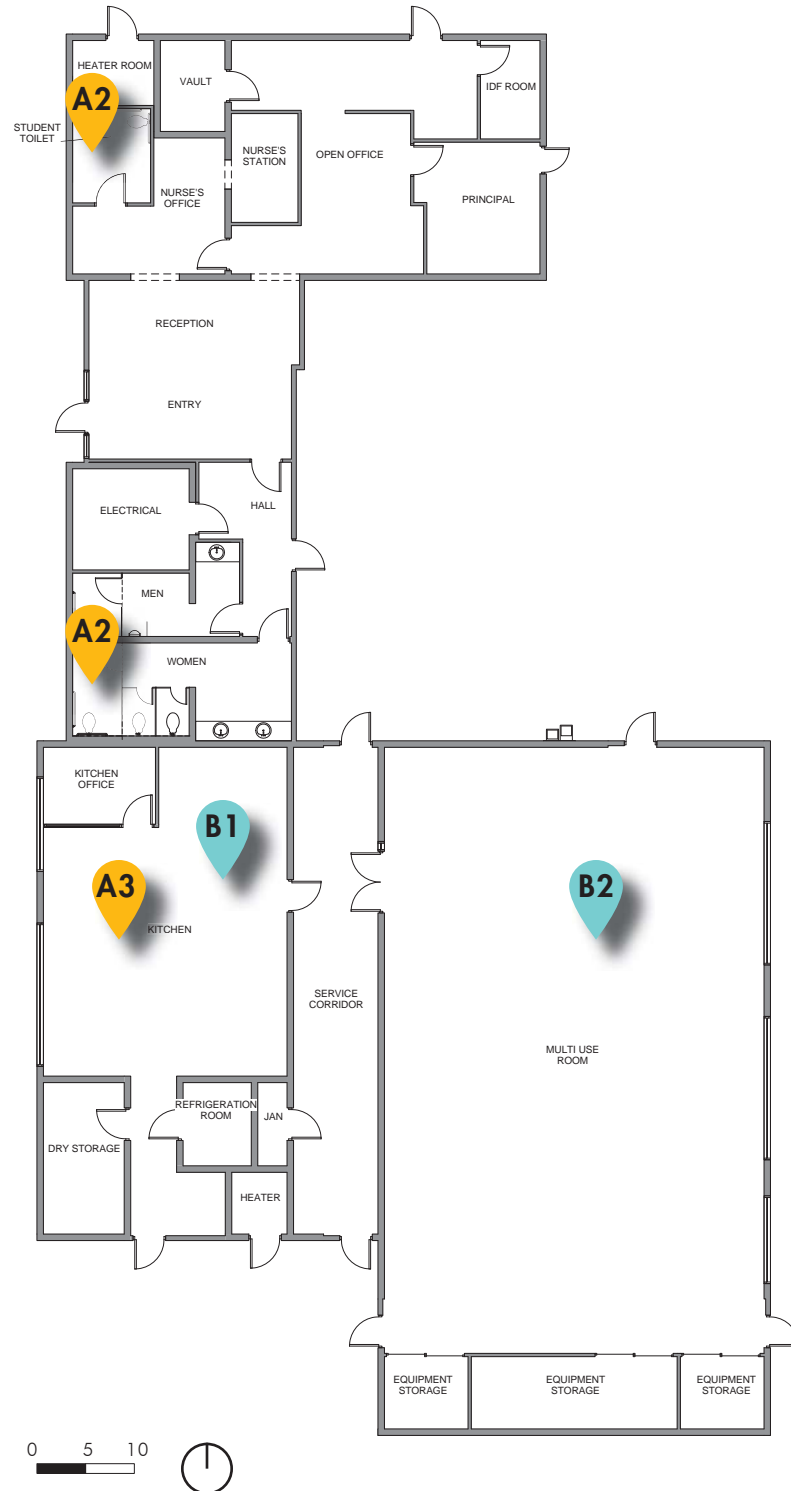
EXISTING FLOOR PLAN: MULTI-PURPOSE ROOM AND ADMINISTRATION

- A1 Wiring on walls is not protected and hanging
- A2 Accessible Toilet accessories not Title 24 compliant
- A3 Kitchen sink does not meet current Title 24 requirements
- A4 Security system issues

- B1 Ceiling tiles in kitchen are stained
- B2 MPR room needs more lighting
- B3 Walls damaged at various locations

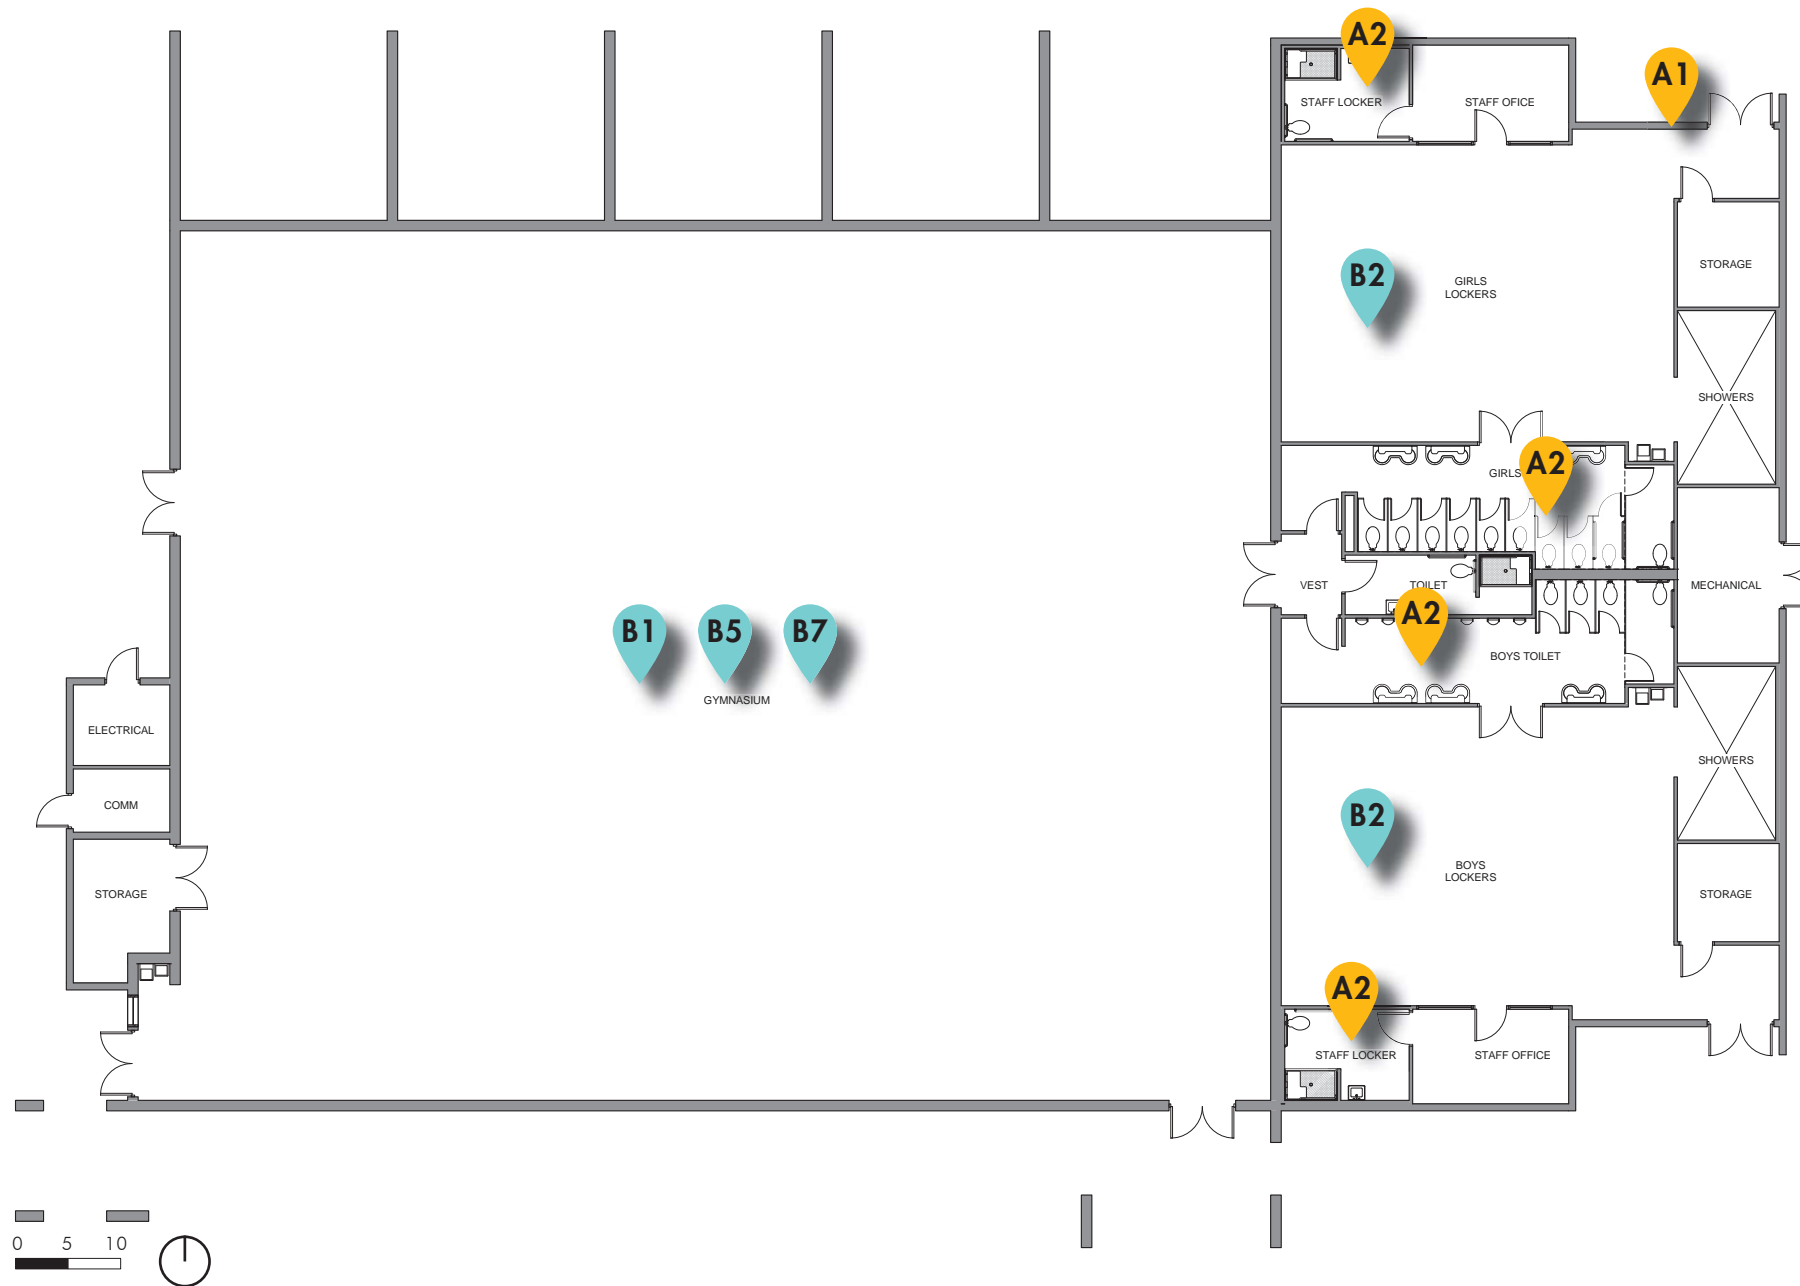
EXISTING FLOOR PLAN: GYMNASIUM

- A1 Room signage not Title 24 compliant
- A2 Accessible Toilet accessories not Title 24 compliant

- B1 Safety padding needs repair
- B2 Hard lid ceilings have cracks and need repair
- B3 Wall base is damaged at various locations
- B4 Exterior plaster is cracked and damaged
- B5 Ceiling has protruding nails
- B6 Empty planters around building
- B7 Score board does not have protective cage

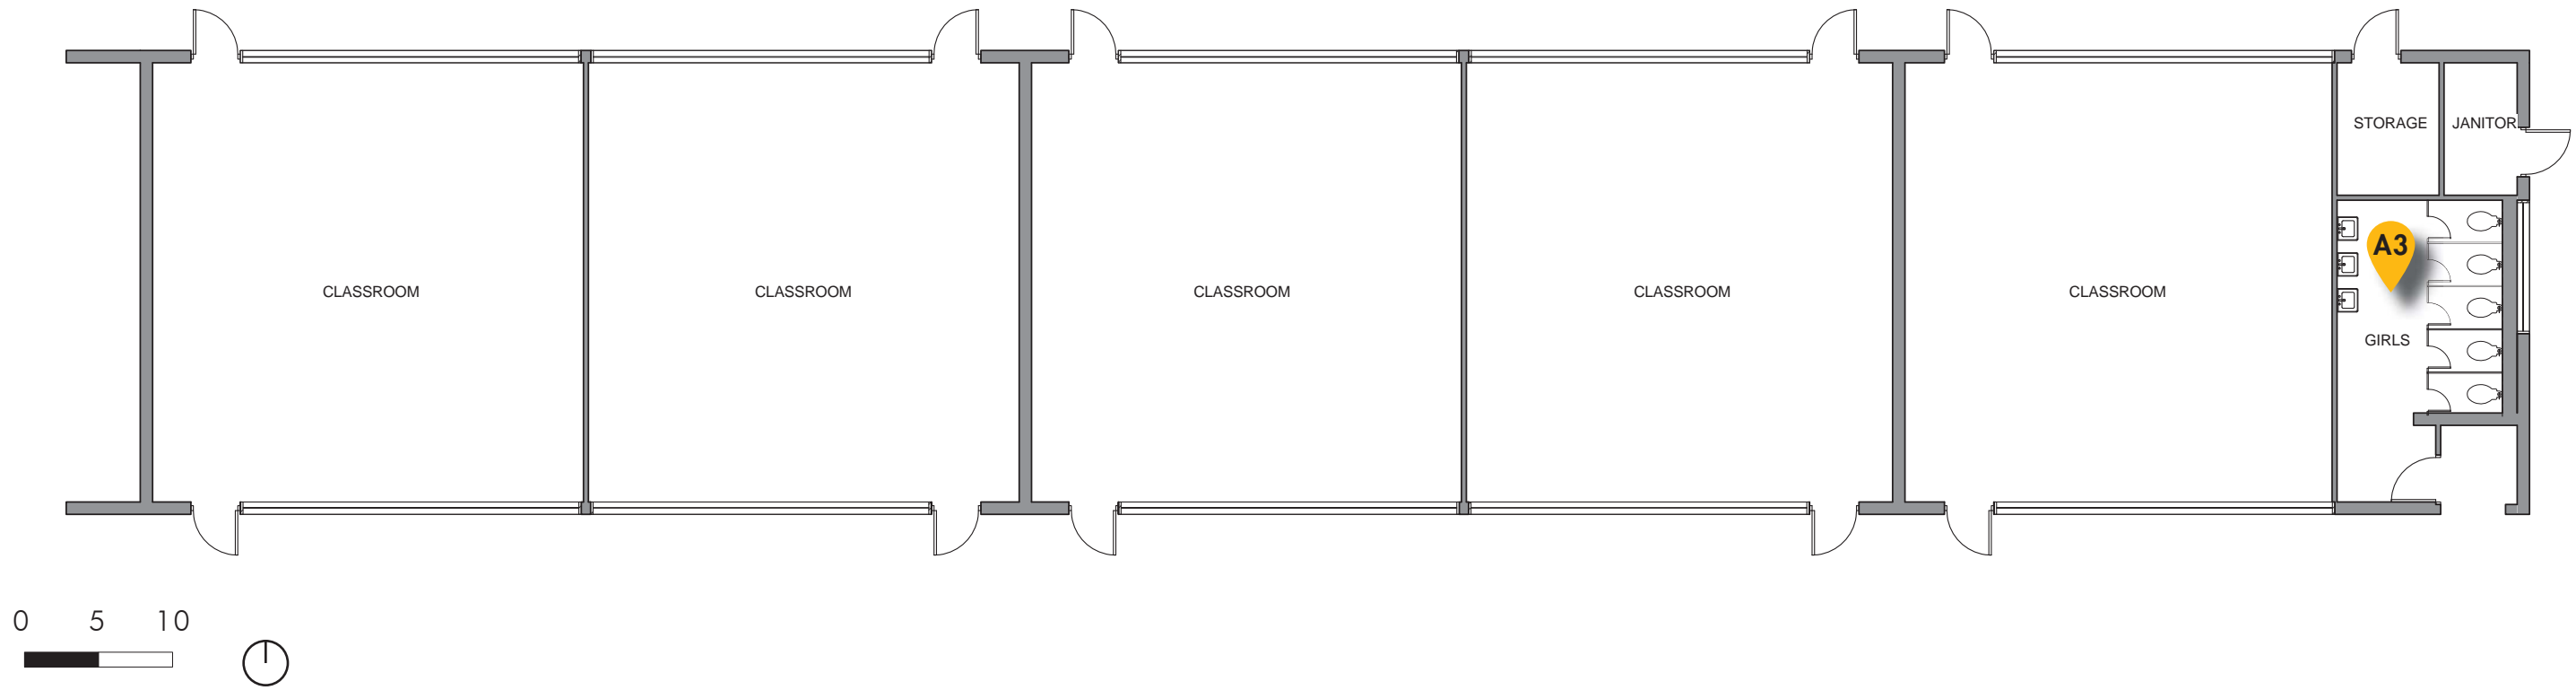
EXISTING FLOOR PLAN: CLASSROOMS

- A1 Electrical cords and wiring taped to floor
- A2 Signage not Title 24 compliant
- A3 Accessible toilet accessories not Title 24 compliant

- B1 Graffiti on exterior walls needs to be removed
- B2 VCT flooring is severely scratched from movement of chairs
- B3 Multiple ceiling tiles have water stains from roof leaking
- B4 Rubber base damaged in various locations

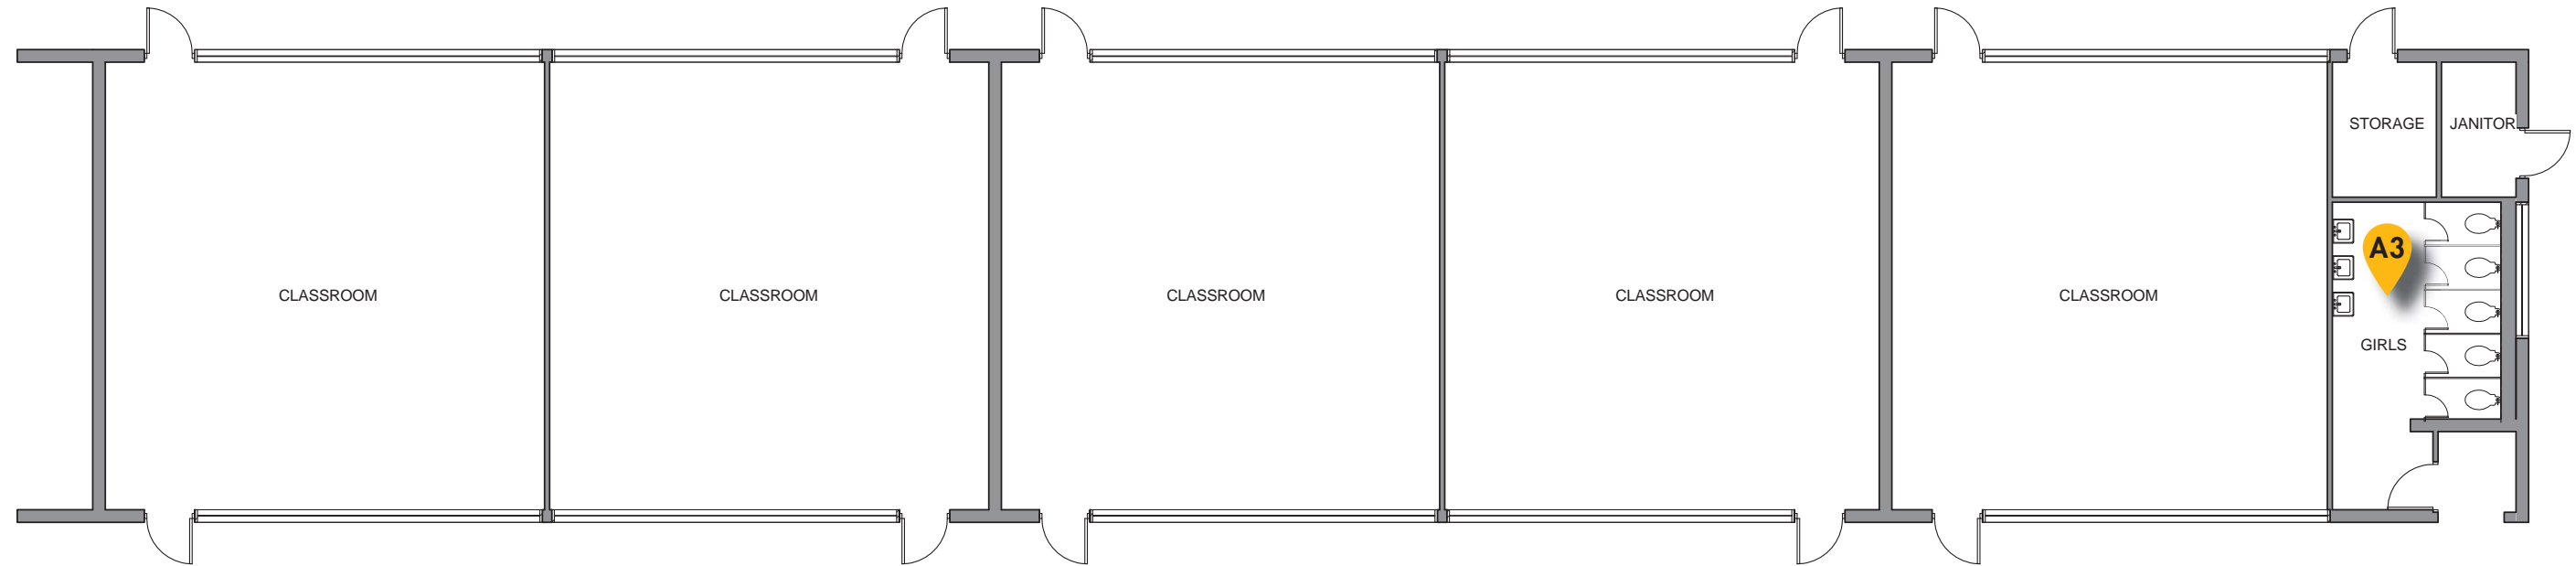
EXISTING FLOOR PLAN: CLASSROOMS

- A1 Electrical cords and wiring taped to floor
- A2 Signage not Title 24 compliant
- A3 Accessible toilet accessories not Title 24 compliant

- B1 Graffiti on exterior walls needs to be removed
- B2 VCT flooring is severely scratched from movement of chairs
- B3 Some ceiling tiles have water stains from above

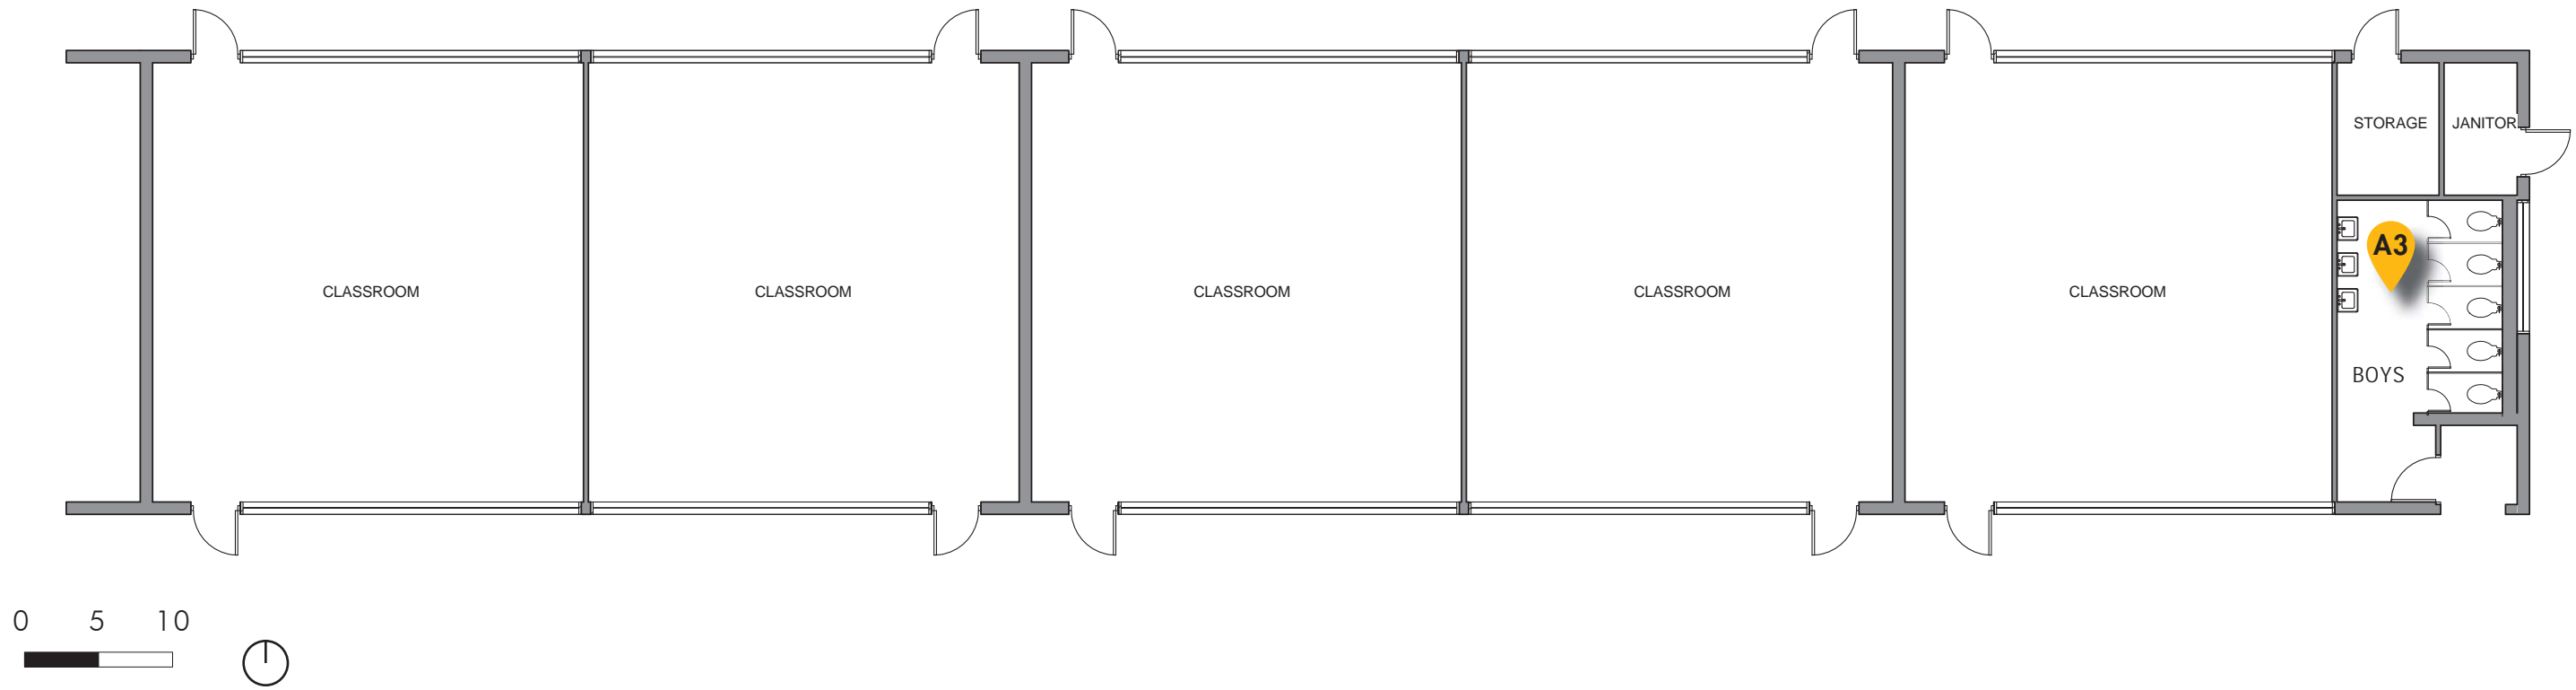
EXISTING FLOOR PLAN: CLASSROOMS

- A1 Electrical cords and wiring taped to floor
- A2 Accessible signage not Title 24 compliant
- A3 Accessible toilet accessories not Title 24 compliant

- B1 Graffiti on exterior walls needs to be removed
- B2 VCT flooring is severely scratched from movement of chairs
- B3 Some ceiling tiles have water stains from above

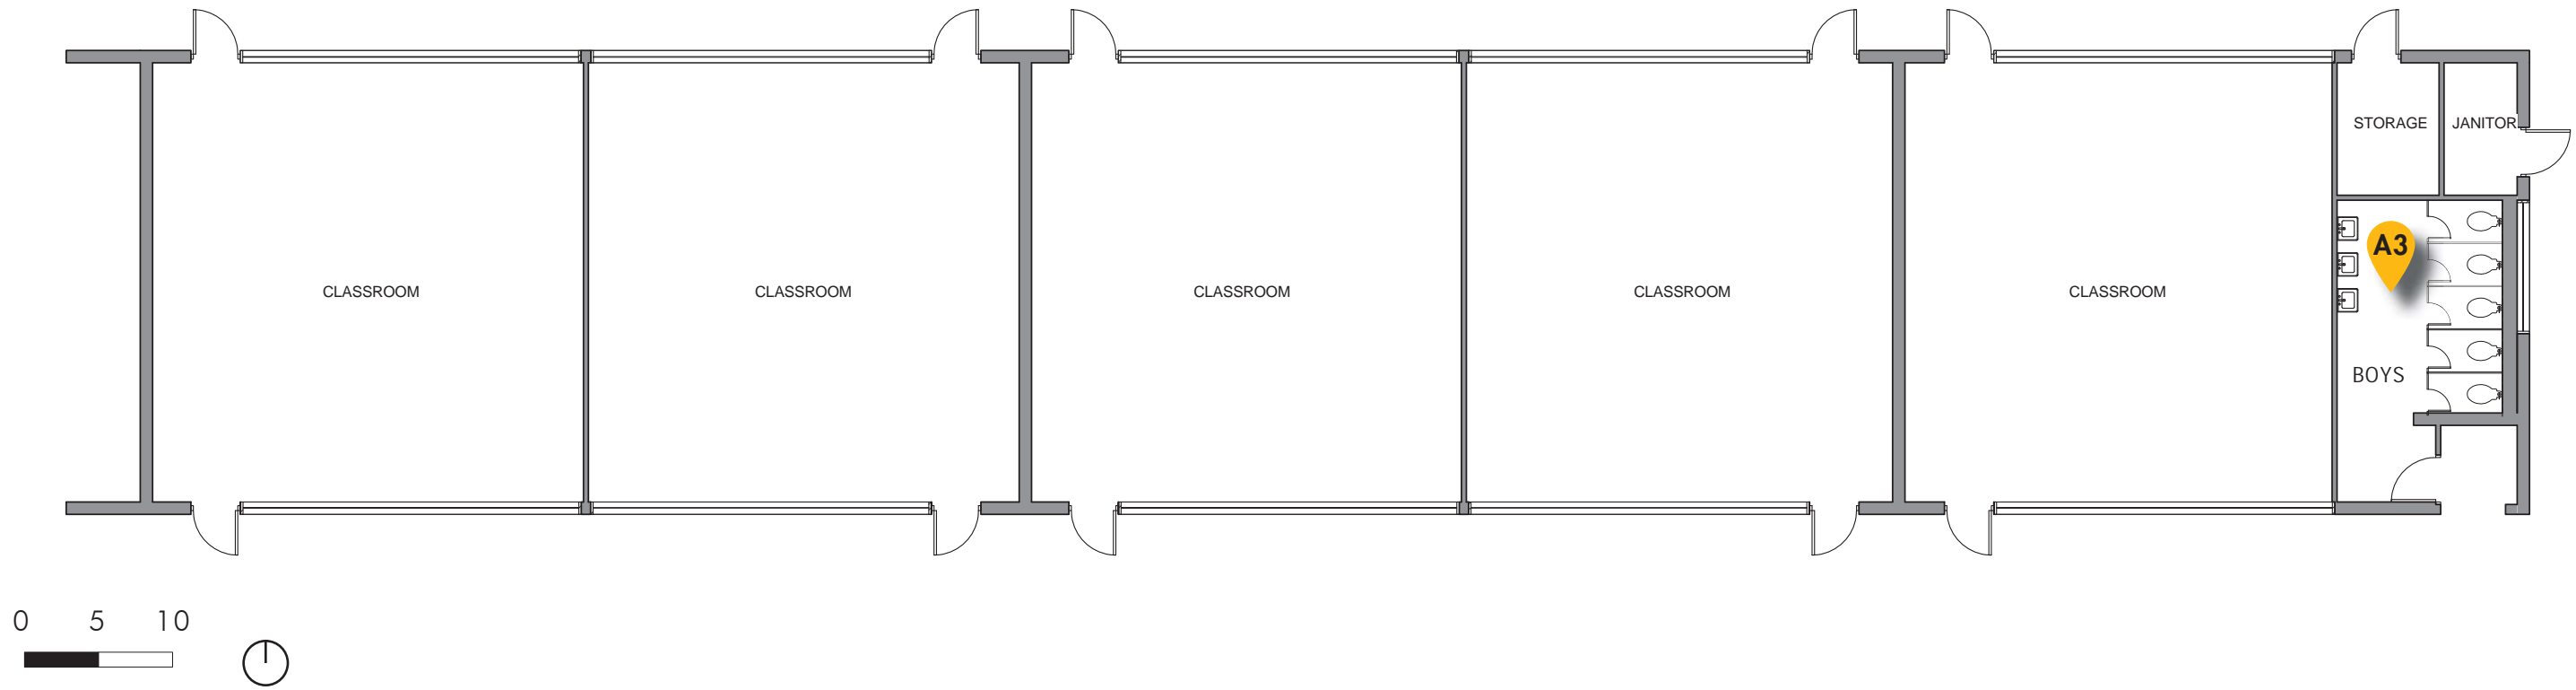
EXISTING FLOOR PLAN: CLASSROOMS

- A1 Electrical cords and wiring taped to floor
- A2 Accessible signage not Title 24 compliant
- A3 Accessible toilet accessories not Title 24 compliant

- B1 Graffiti on exterior walls needs to be removed
- B2 VCT flooring is severely scratched from movement of chairs
- B3 Some ceiling tiles have water stains from above

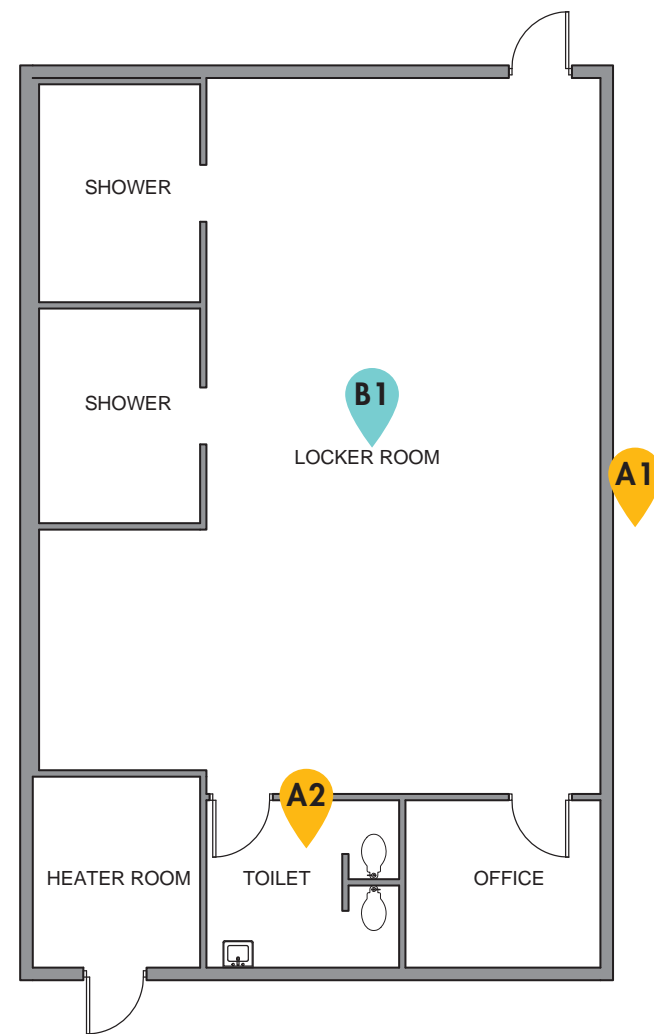
EXISTING FLOOR PLAN: FITNESS CENTER

- A1 Building is not Title 24 compliant
- A2 Drinking fountain is not Title 24 compliant
- A3 Restroom is not title 24 compliant

- B1 Not enough lighting
- B2 Ceiling cracked and water stained
- B3 VCT flooring cracked and damaged
- B4 Paint is chipped and peeling
- B5 Fascia boards are warped

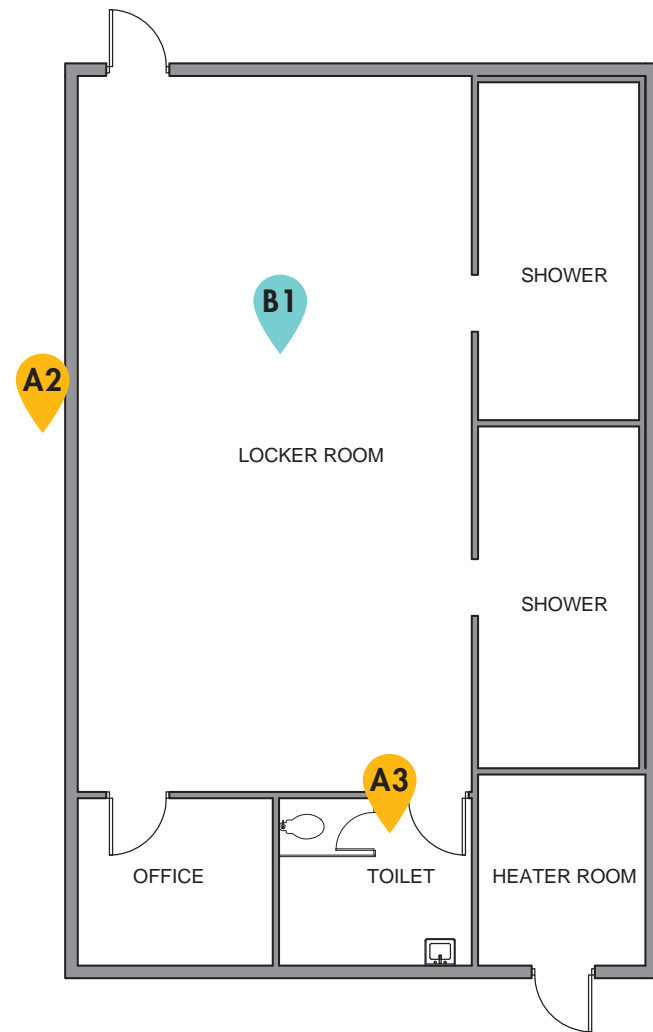
EXISTING FLOOR PLAN: UNIFORM & BOOK STORAGE

- A1 Building is not Title 24 compliant
- A2 Drinking fountain is not Title 24 compliant
- A3 Restroom is not title 24 compliant
- A4 Exterior light fixture damaged

- B1 Not enough lighting
- B2 Ceiling cracked and water stained
- B3 VCT flooring cracked and damaged
- B4 Paint is chipped and peeling
- B5 Fascia boards are warped

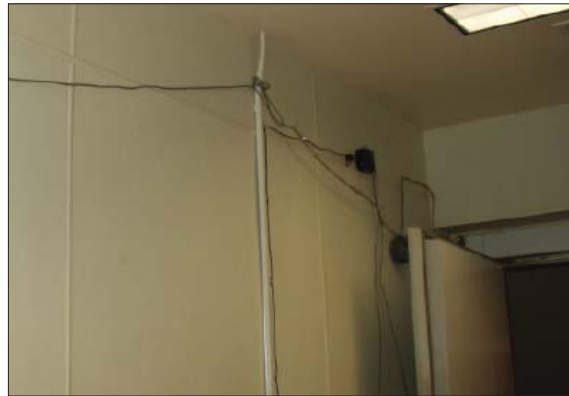
Wiring is exposed and hanging on wall

There are electrical cords and various wiring hanging on the walls which can become a fire hazard.

Solution: Provide new wiremold to cover the wires or reroute to a safe location.

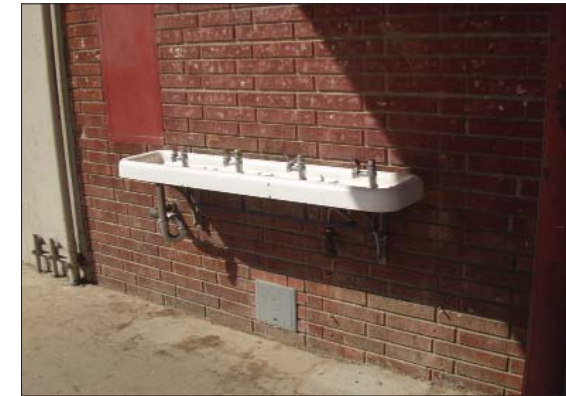
Drinking fountains are not Title 24 compliant

Drinking fountains do not comply with Title 24 requirements.

Solution: Provide drinking fountains that comply with Title 24 requirements.

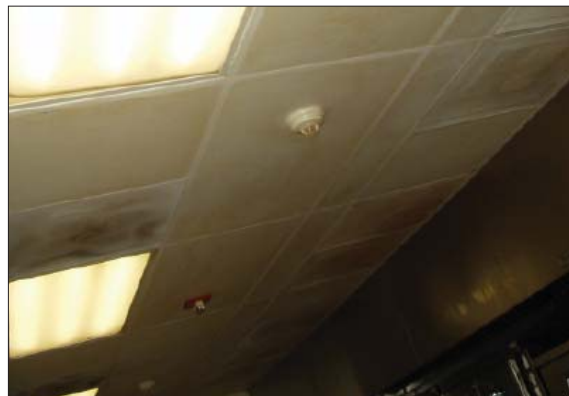
Ceiling tiles in Kitchen are stained

Many ceiling tiles in the Kitchen are stained with grease.

Solution: Provide new ceiling tiles that can resist grease.

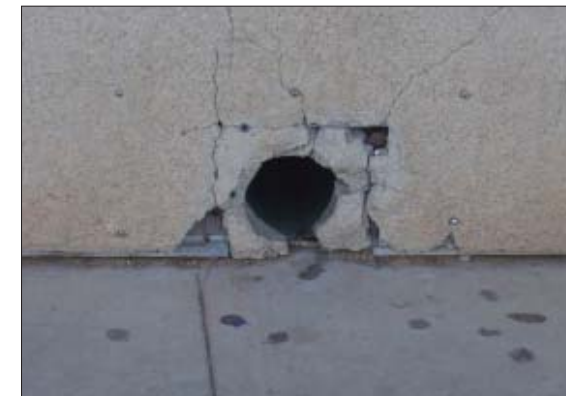
Holes in exterior plaster

Exterior plaster walls is damaged in various locations that can lead to water entering the building.

Solution: Patch up holes and cracks at exterior plaster walls.

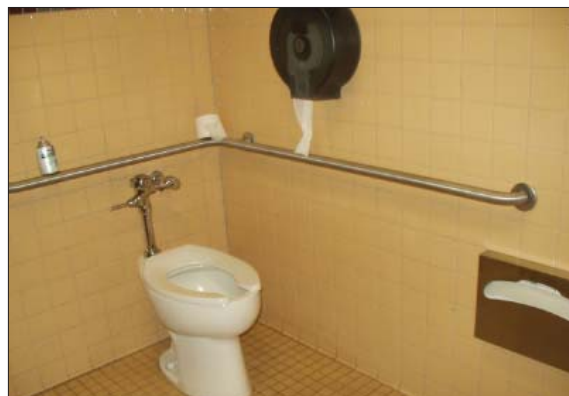
Accessible toilet accessories are not Title 24 compliant

Many toilet accessories in accessible stalls are not compliant with Title 24 requirements.

Solution: Provide toilet accessories that comply with Title 24 requirements.

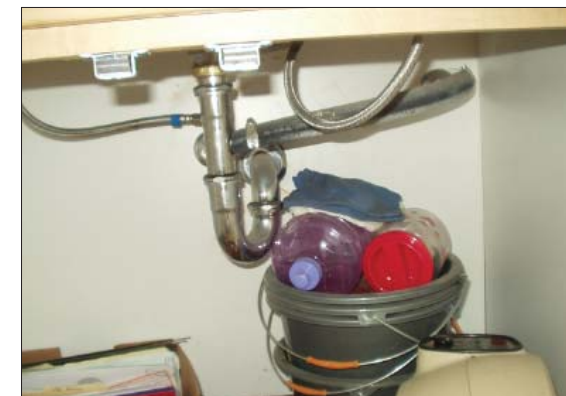
Accessible sinks missing pipe cover

Some accessible sinks are missing the pipe cover which covers the hot water pipe. This is also required per Title 24.

Solution: Provide pipe covers at accessible sinks where needed.

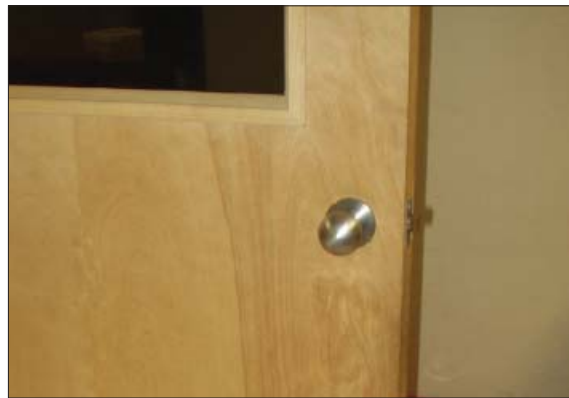
Doors knobs not accessible

Some doors knobs are not accessible per Title 24 requirements.

Solution: Replace door knobs with door handles that comply with Title 24.

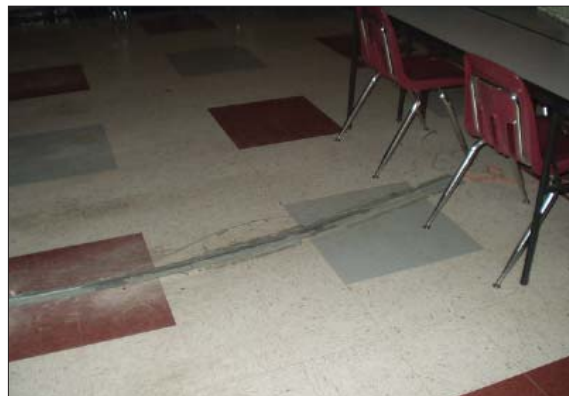
Wires are taped to floors

Some wiring is temporarily taped to the floor which can become a tripping and fire hazard.

Solution: Reroute wiring to come from ceiling with drop down poles or wiremold from the walls.

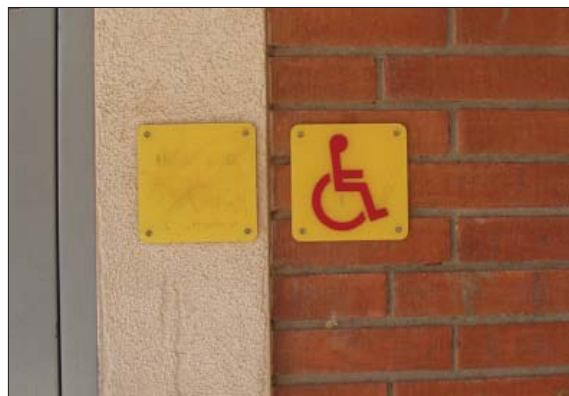
Accessible signage not Title 24 compliant

Signage does not comply with Title 24 requirements.

Solution: Replace with Title 24 compliant accessible signage.

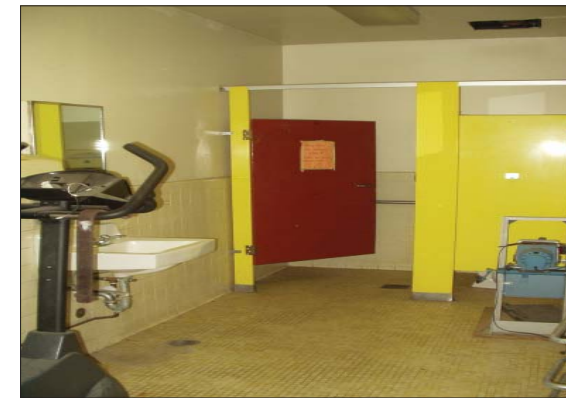
Restrooms not accessible

Restrooms do not meet current Title 24 requirements

Solution: Remodel to meet current Title 24 requirements

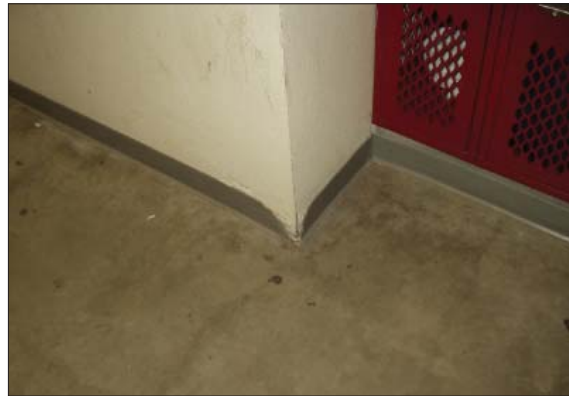
Rubber base damaged

The rubber base at wall corners is damaged and needs to be repaired

Solution: Provide new rubber base at corners where damaged.

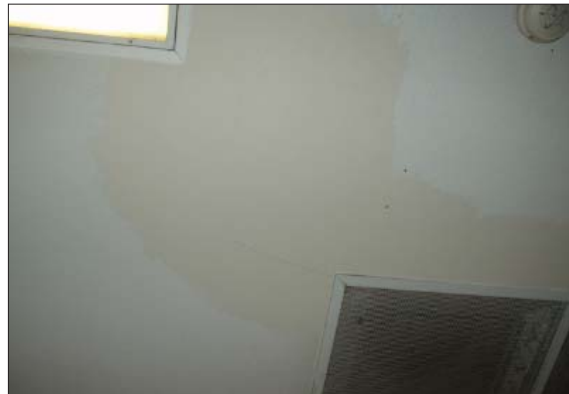
Ceiling cracks

Some of the hard lid ceilings have cracks.

Solution: Patch and repair cracks where needed.

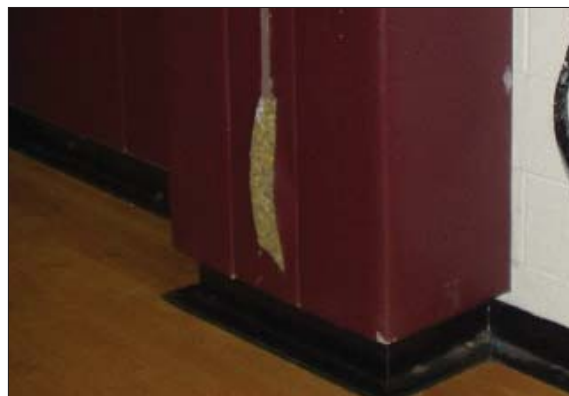
Gym padding equipment torn

Some of the padding equipment in the gym has torn.

Solution: Repair torn padding equipment to prevent further damage.

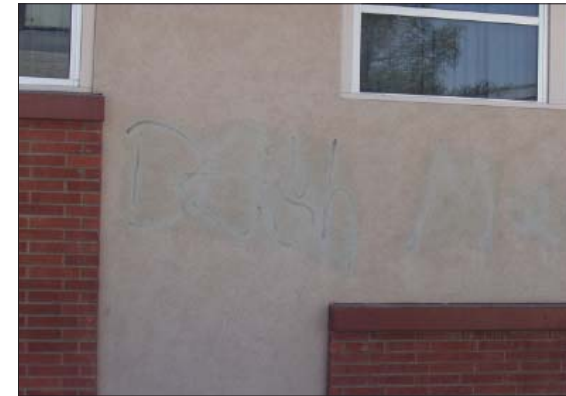
Graffiti at exterior walls

There is graffiti on the exterior walls that need to be removed.

Solution: Remove graffiti.

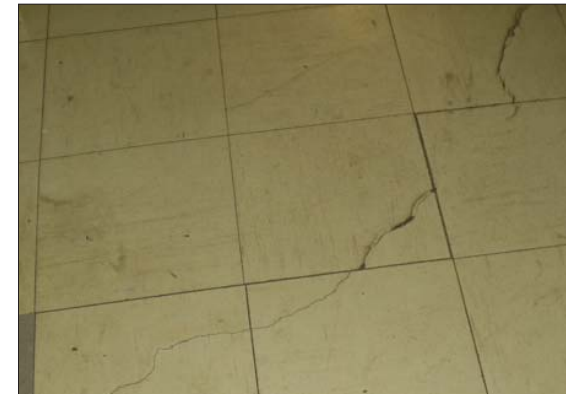
VCT flooring cracked and damaged

VCT flooring is cracked and damaged in various locations.

Solution: Provide new VCT where needed.
