CALEXICO HIGH SCHOOL 9TH GRADE CAMPUS

824 Blair Avenue, Calexico, CA 92231

EXISTING SITE CONDITIONS

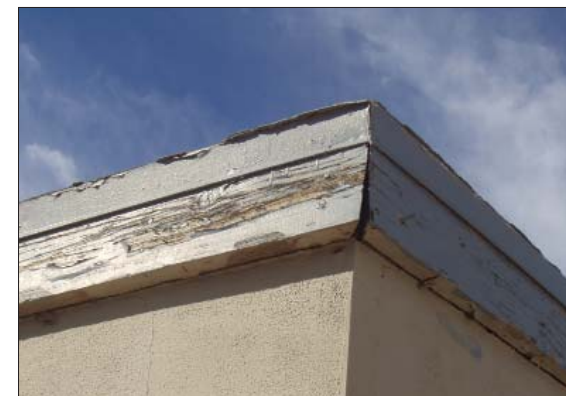
Paint and fascia boards

Paint is peeling and cracked throughout the campus. Many fascia boards are warped.

Solution: Paint buildings as needed and provide new fascia boards as needed.
