CALEXICO HIGH SCHOOL 9TH GRADE CAMPUS

824 Blair Avenue, Calexico, CA 92231

EXISTING SITE CONDITIONS

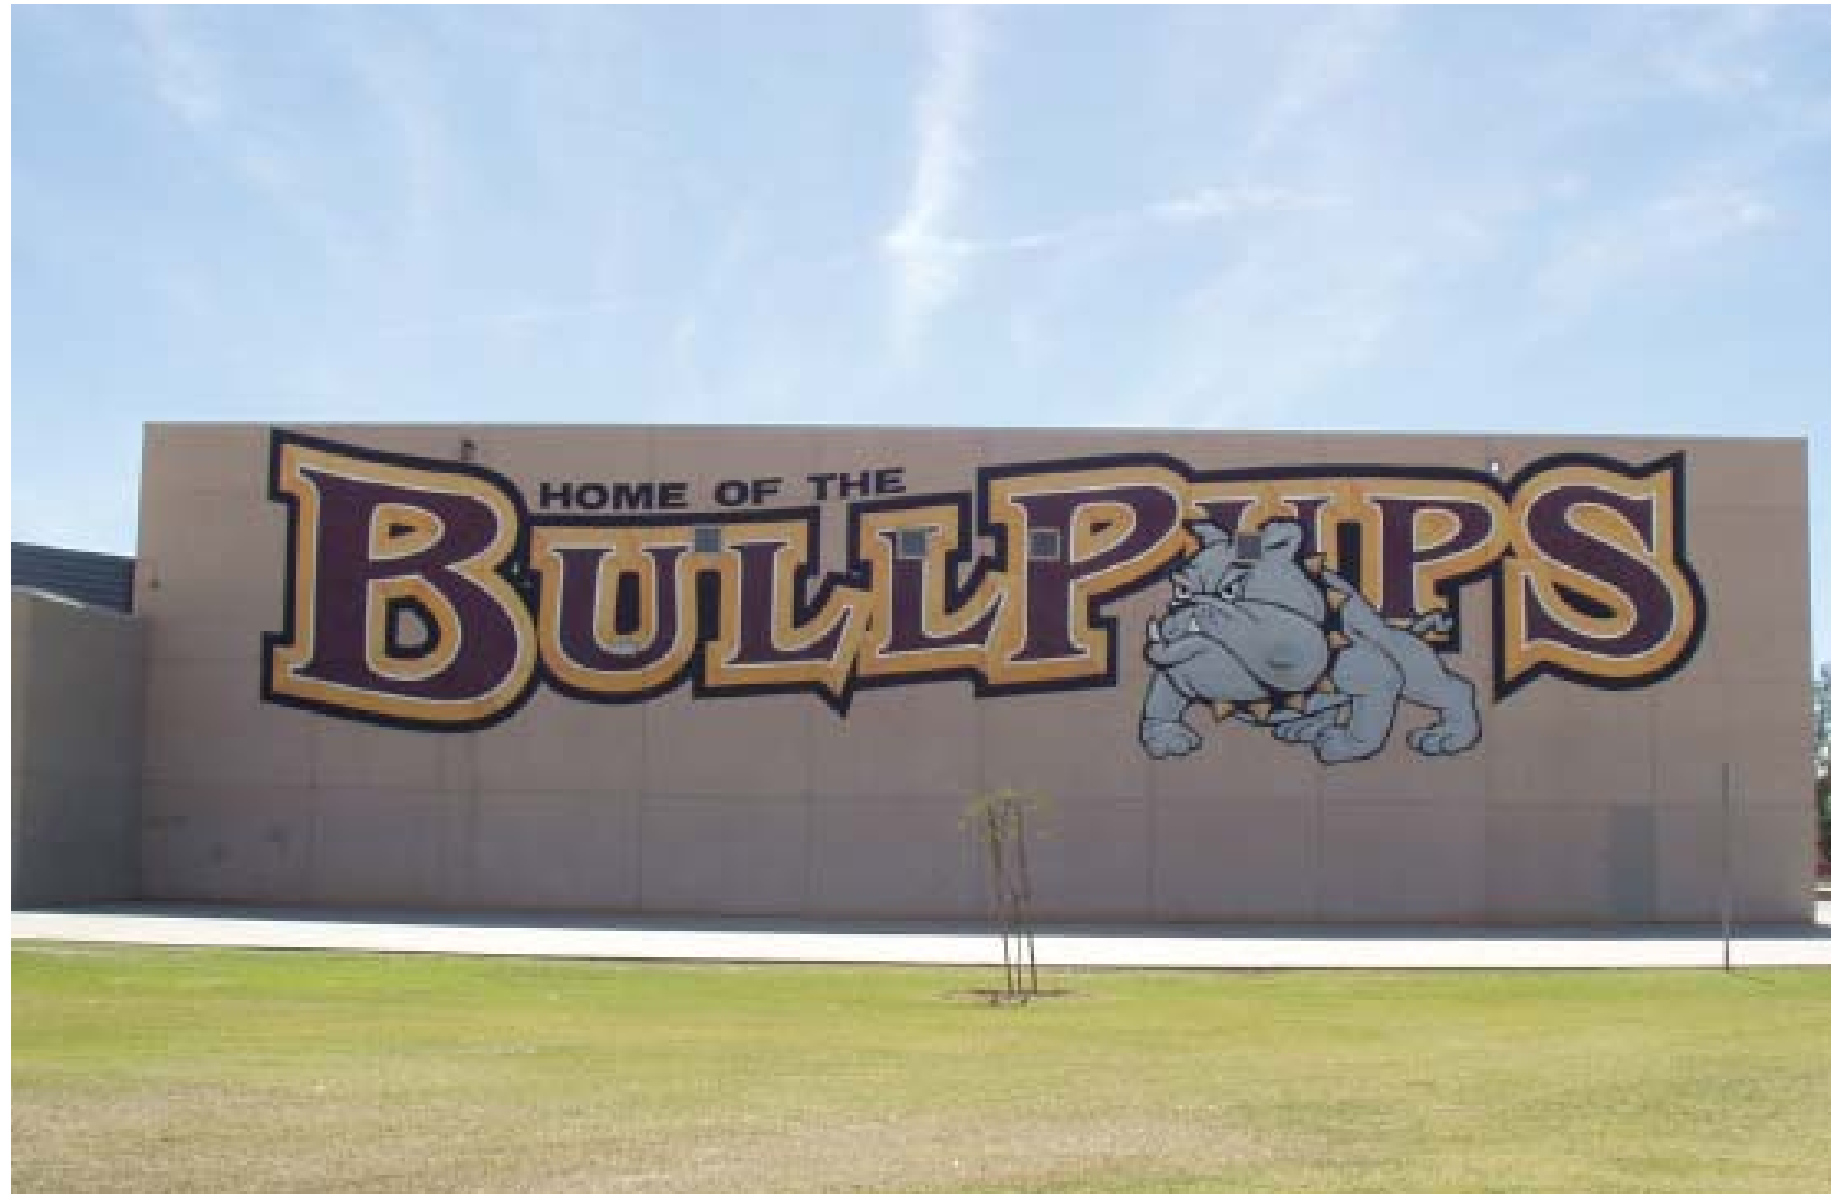
- A1 Concrete walkways are pitted and uneven
- A2 Chainlink gates need accessible hardware
- A3 Asphalt paving deteriorated
- A4 Path of travel not Title 24 compliant
- A5 Site is not title 24 compliant
- A6 Not enough shade structures and trees
- A7 Chainlink fencing damaged
- A8 Existing shade structure fabric deteriorated
- A9 Empty tree wells

- B1 Too many portables
- B2 Roofs are deteriorating
- B3 Basketball and volleyball nets deteriorated
- B4 Baseball backstops need replacing
- B5 Soil eroding in fields
- B6 Paint peeling and cracking
- B7 Signage peeling and faded and damaged
- B8 Gravel infill

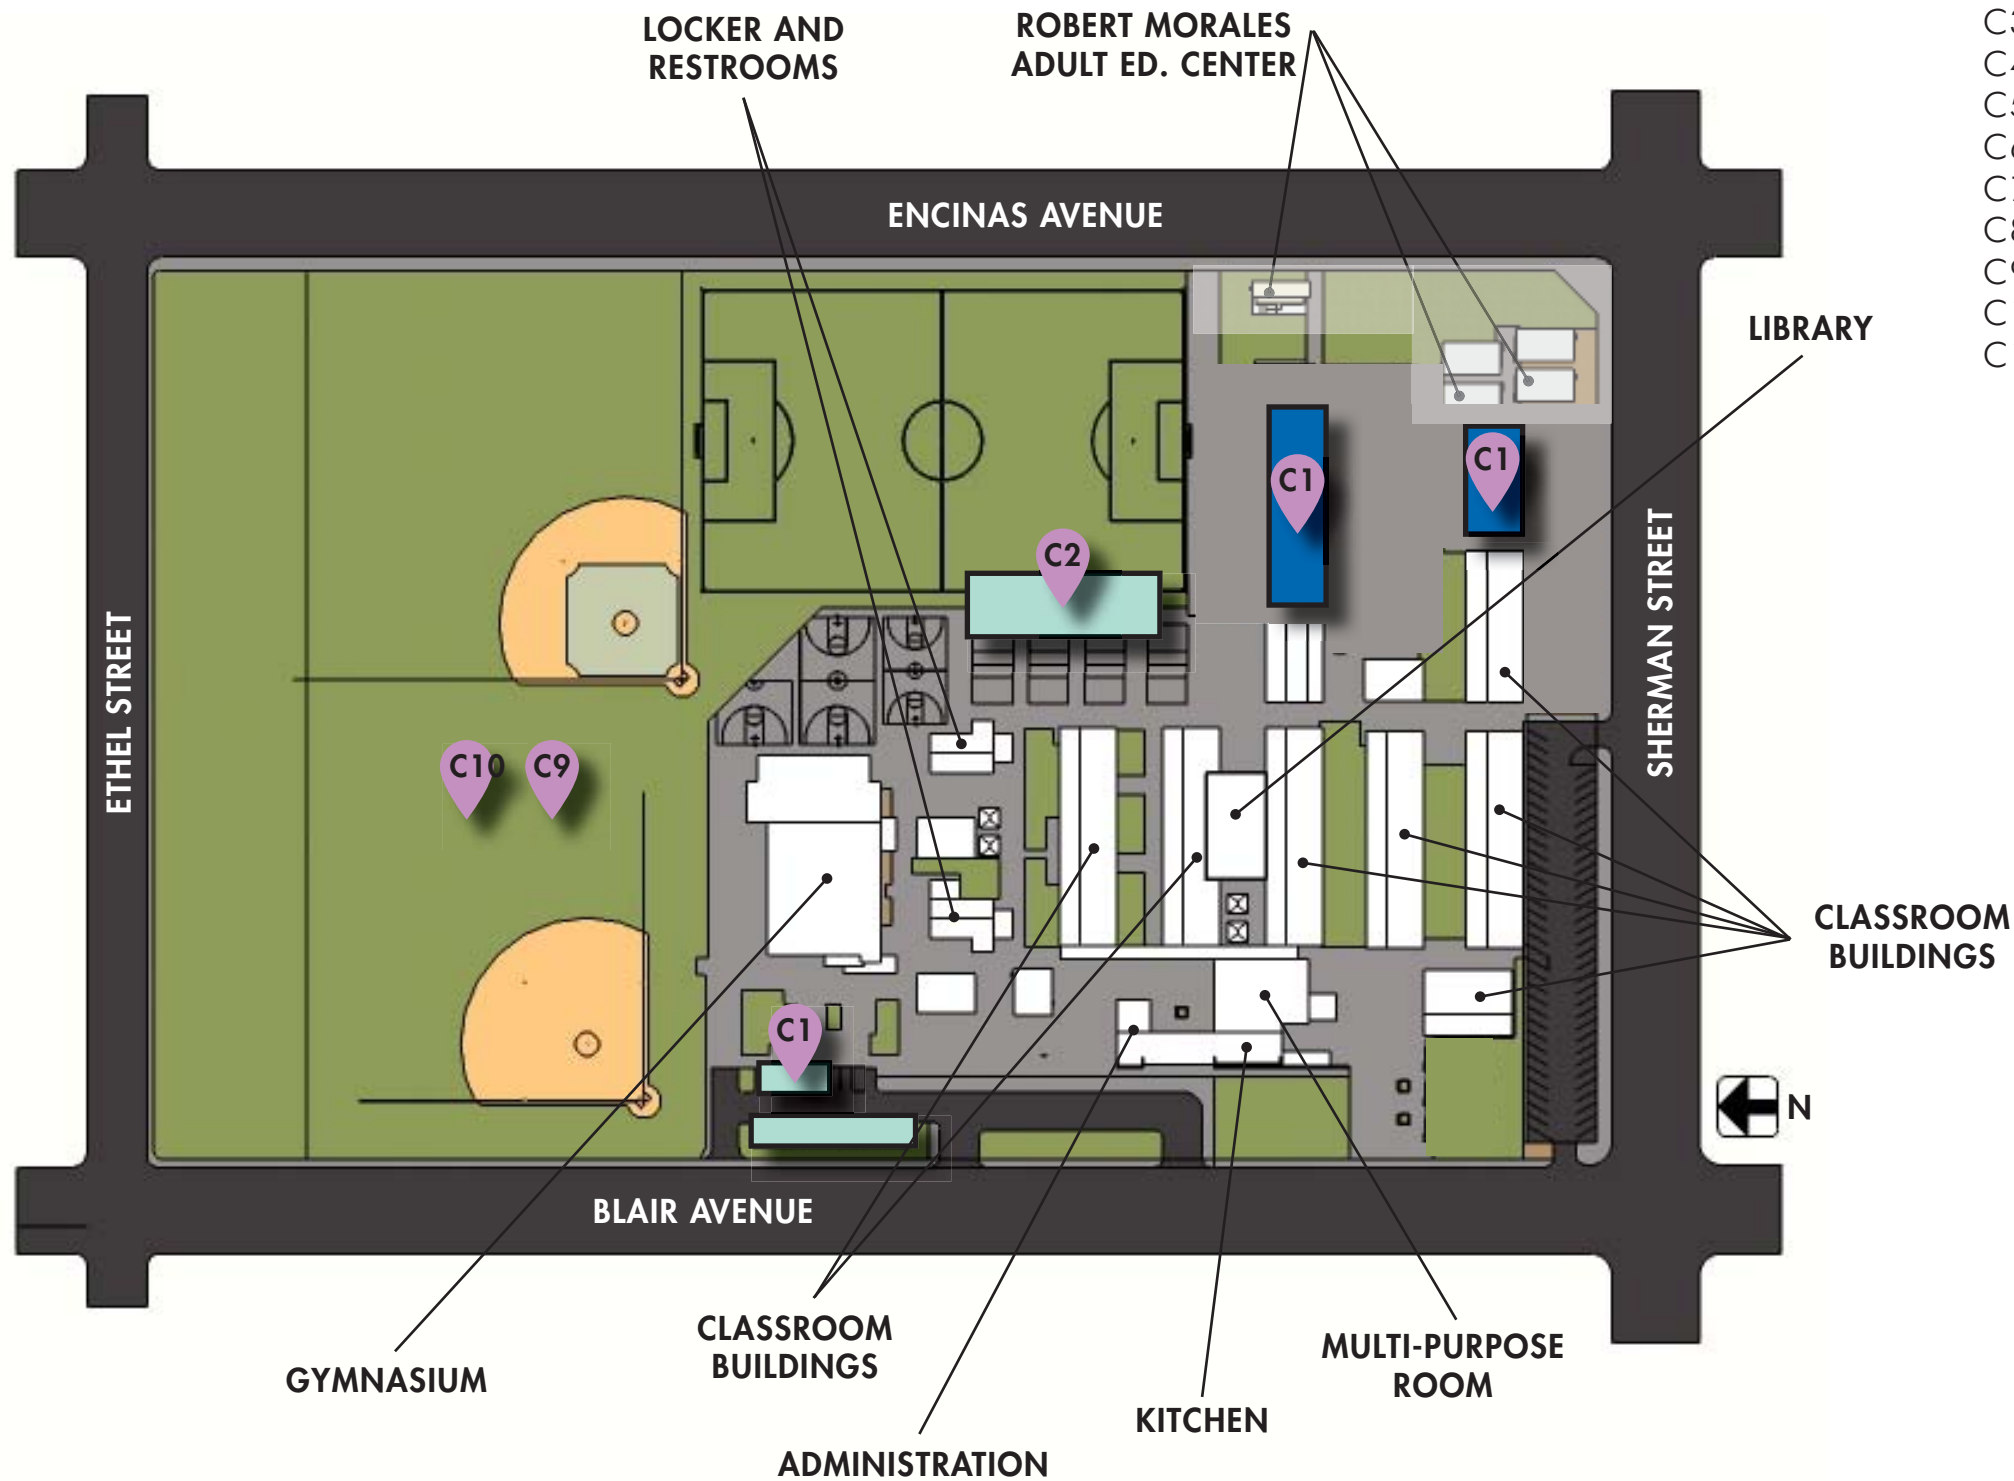
ENVISIONED SITE PLAN

- C1 New classroom buildings
- C2 New solar panels
- C3 New shade structures
- C4 New chainlink fencing
- C5 New asphalt paving
- C6 New concrete paving
- C7 New roofs on permanent buildings
- C8 New sports netting
- C9 New backstops
- C10 Import soil, regrade and seed sports fields
- C11 New Title 24 compliant signage
